CORNER RECORD

Document Number 07-0347

City of Murrieta County of Riverside, California

Brief Legal Description Alta Murrieta Drive & Birch Tree Drive SEC. 15, T7S, R3W

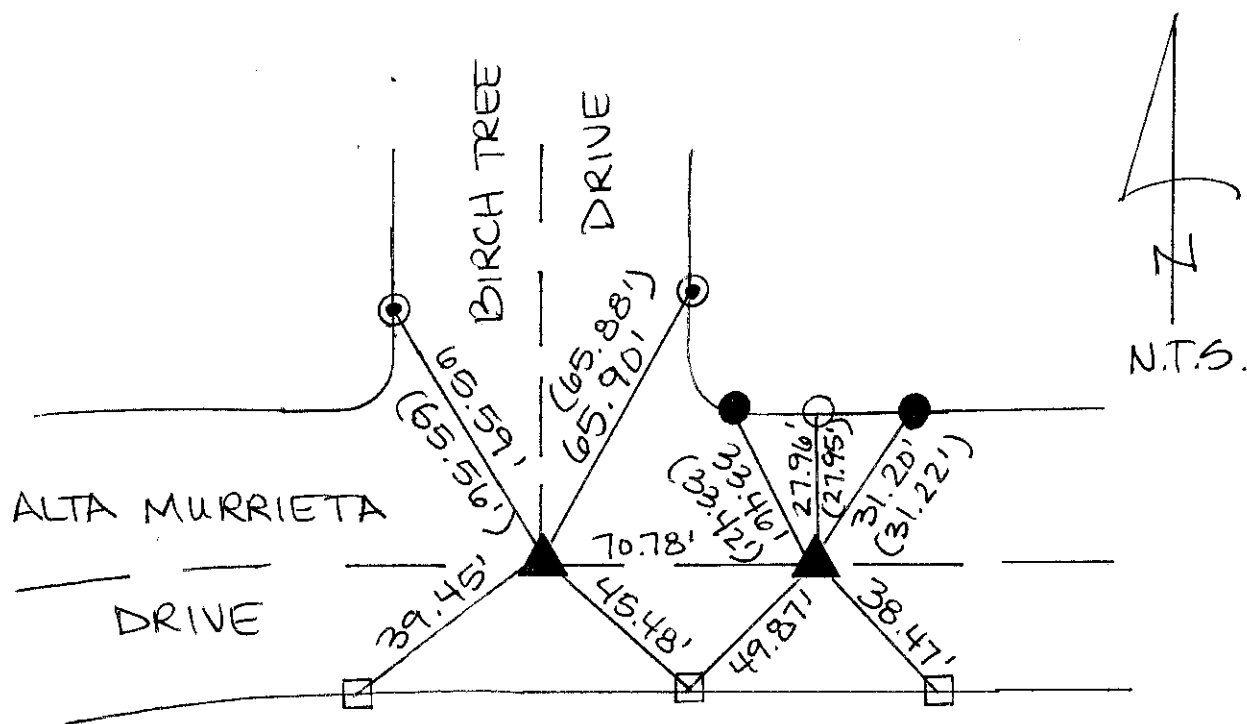
R-1= Co. OF RIVERSIDE CR 02-20
 () = REC. DIST. PER R-1.

- ▲ FD. SPK/W L.S. 5411 FLUSH (PER R-1) BEFORE & AFTER CONSTR.
- FD. L/TACK (PER R-1) IN T.C., ADDED TAG L.S. 5411.
- ⊙ FD. L/T L.S. 5411 IN T.C. (PER R-1).
- FD. L/T & TAG MARKED "DE & RP" (PER R-1) IN T.C.
- SET L/T L.S. 5411 IN T.C.
