CORNER RECORD

Document Number 07-0349

City of Murrieta County of Riverside, California

Brief Legal Description Alta Murrieta Drive & Ridgeplume Drive SEC. 15, T7S, R3W
TEMECULA RANCHO

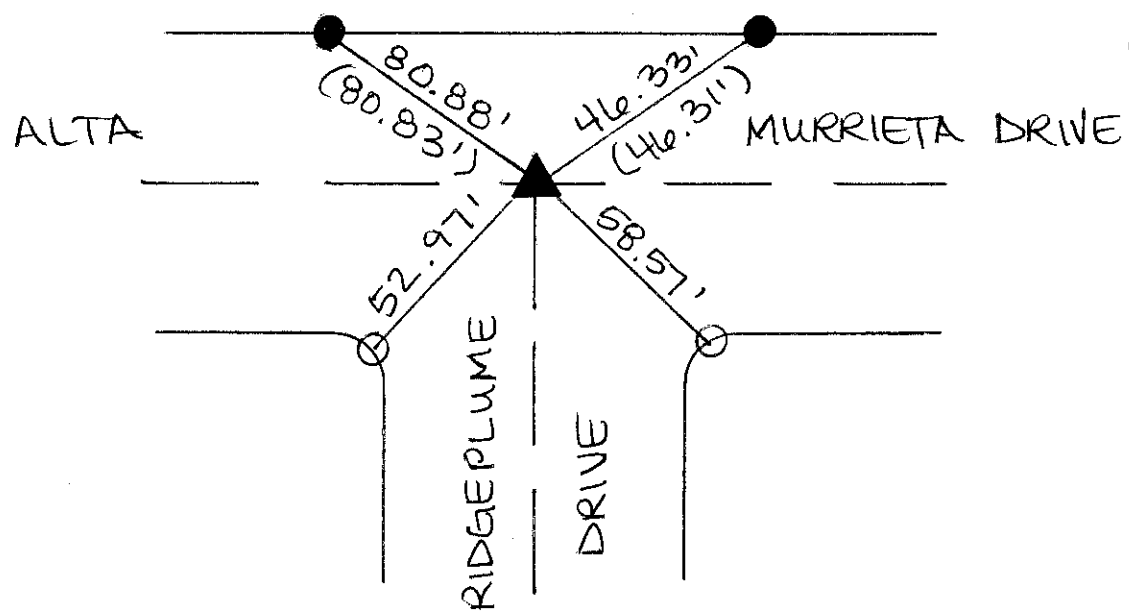
R-1 = CO. OF RIVERSIDE CR 02-19
 () = REC. DIST. PER R-1.

- ▲ FD. SPK | W L.S. 5411 FLUSH (PER R-1) BEFORE & AFTER CONSTR.
- FD. L/T & TAG L.S. 5411 IN T.C. (PER R-1).
- SET L/T & TAG L.S. 5411 IN T.C.
